Investigation into the impact of sewage effluent discharges on water quality in the Freshwater East area, Pembrokeshire

August 2012

Environment Agency Wales. 2012. Hydrogeological assessment of Freshwater East, Pembrokeshire. Internal Report.

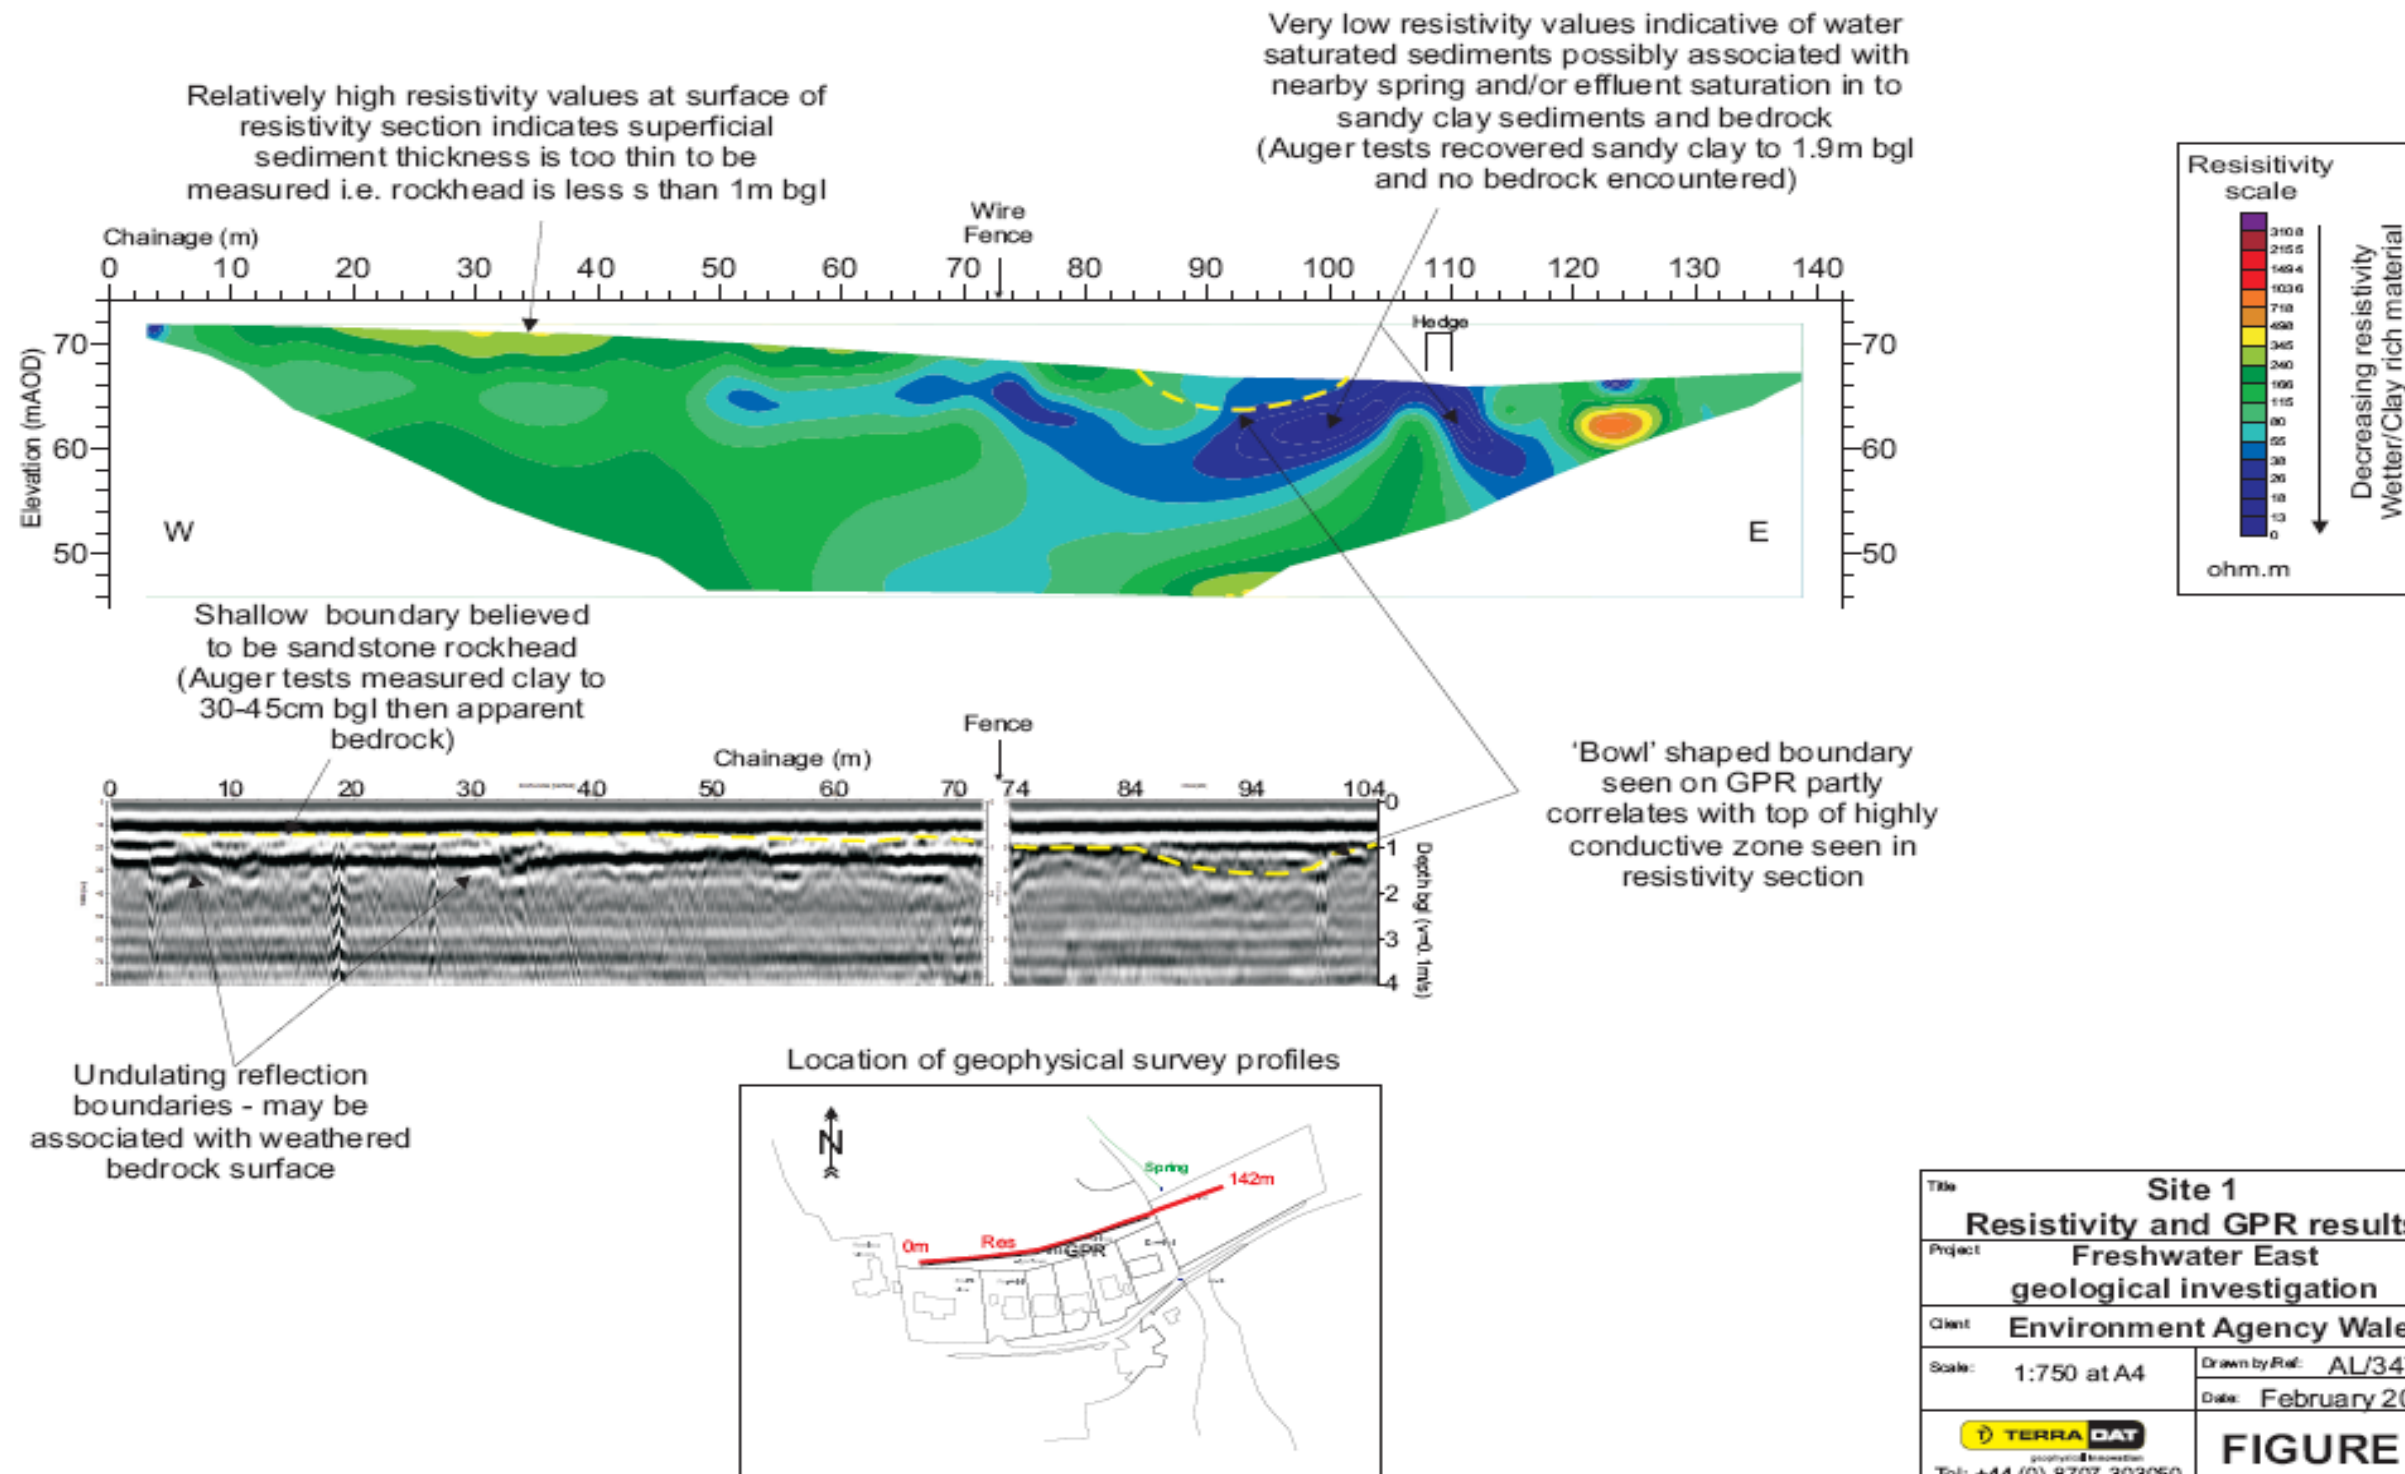
Figure 6 : Geophysical Cross Section 1. Rear of Jason Road

This comprised a 140m survey line (Figure 6) running almost east west behind the houses at the eastern end of Jason Road. This line was used to follow the rear of the properties where ponded effluent has been observed. Five hand augured holes were also made to compliment the geophysical work.

Investigations proved that the thickness of soil behind the houses ranged from 30-45 cm with bedrock encountered below. However in the area behind Eastfield (Site 21 – foul effluent) a 1.9m depth of clay was encountered. This would explain why foul effluent was ponding on the ground surface at this location.

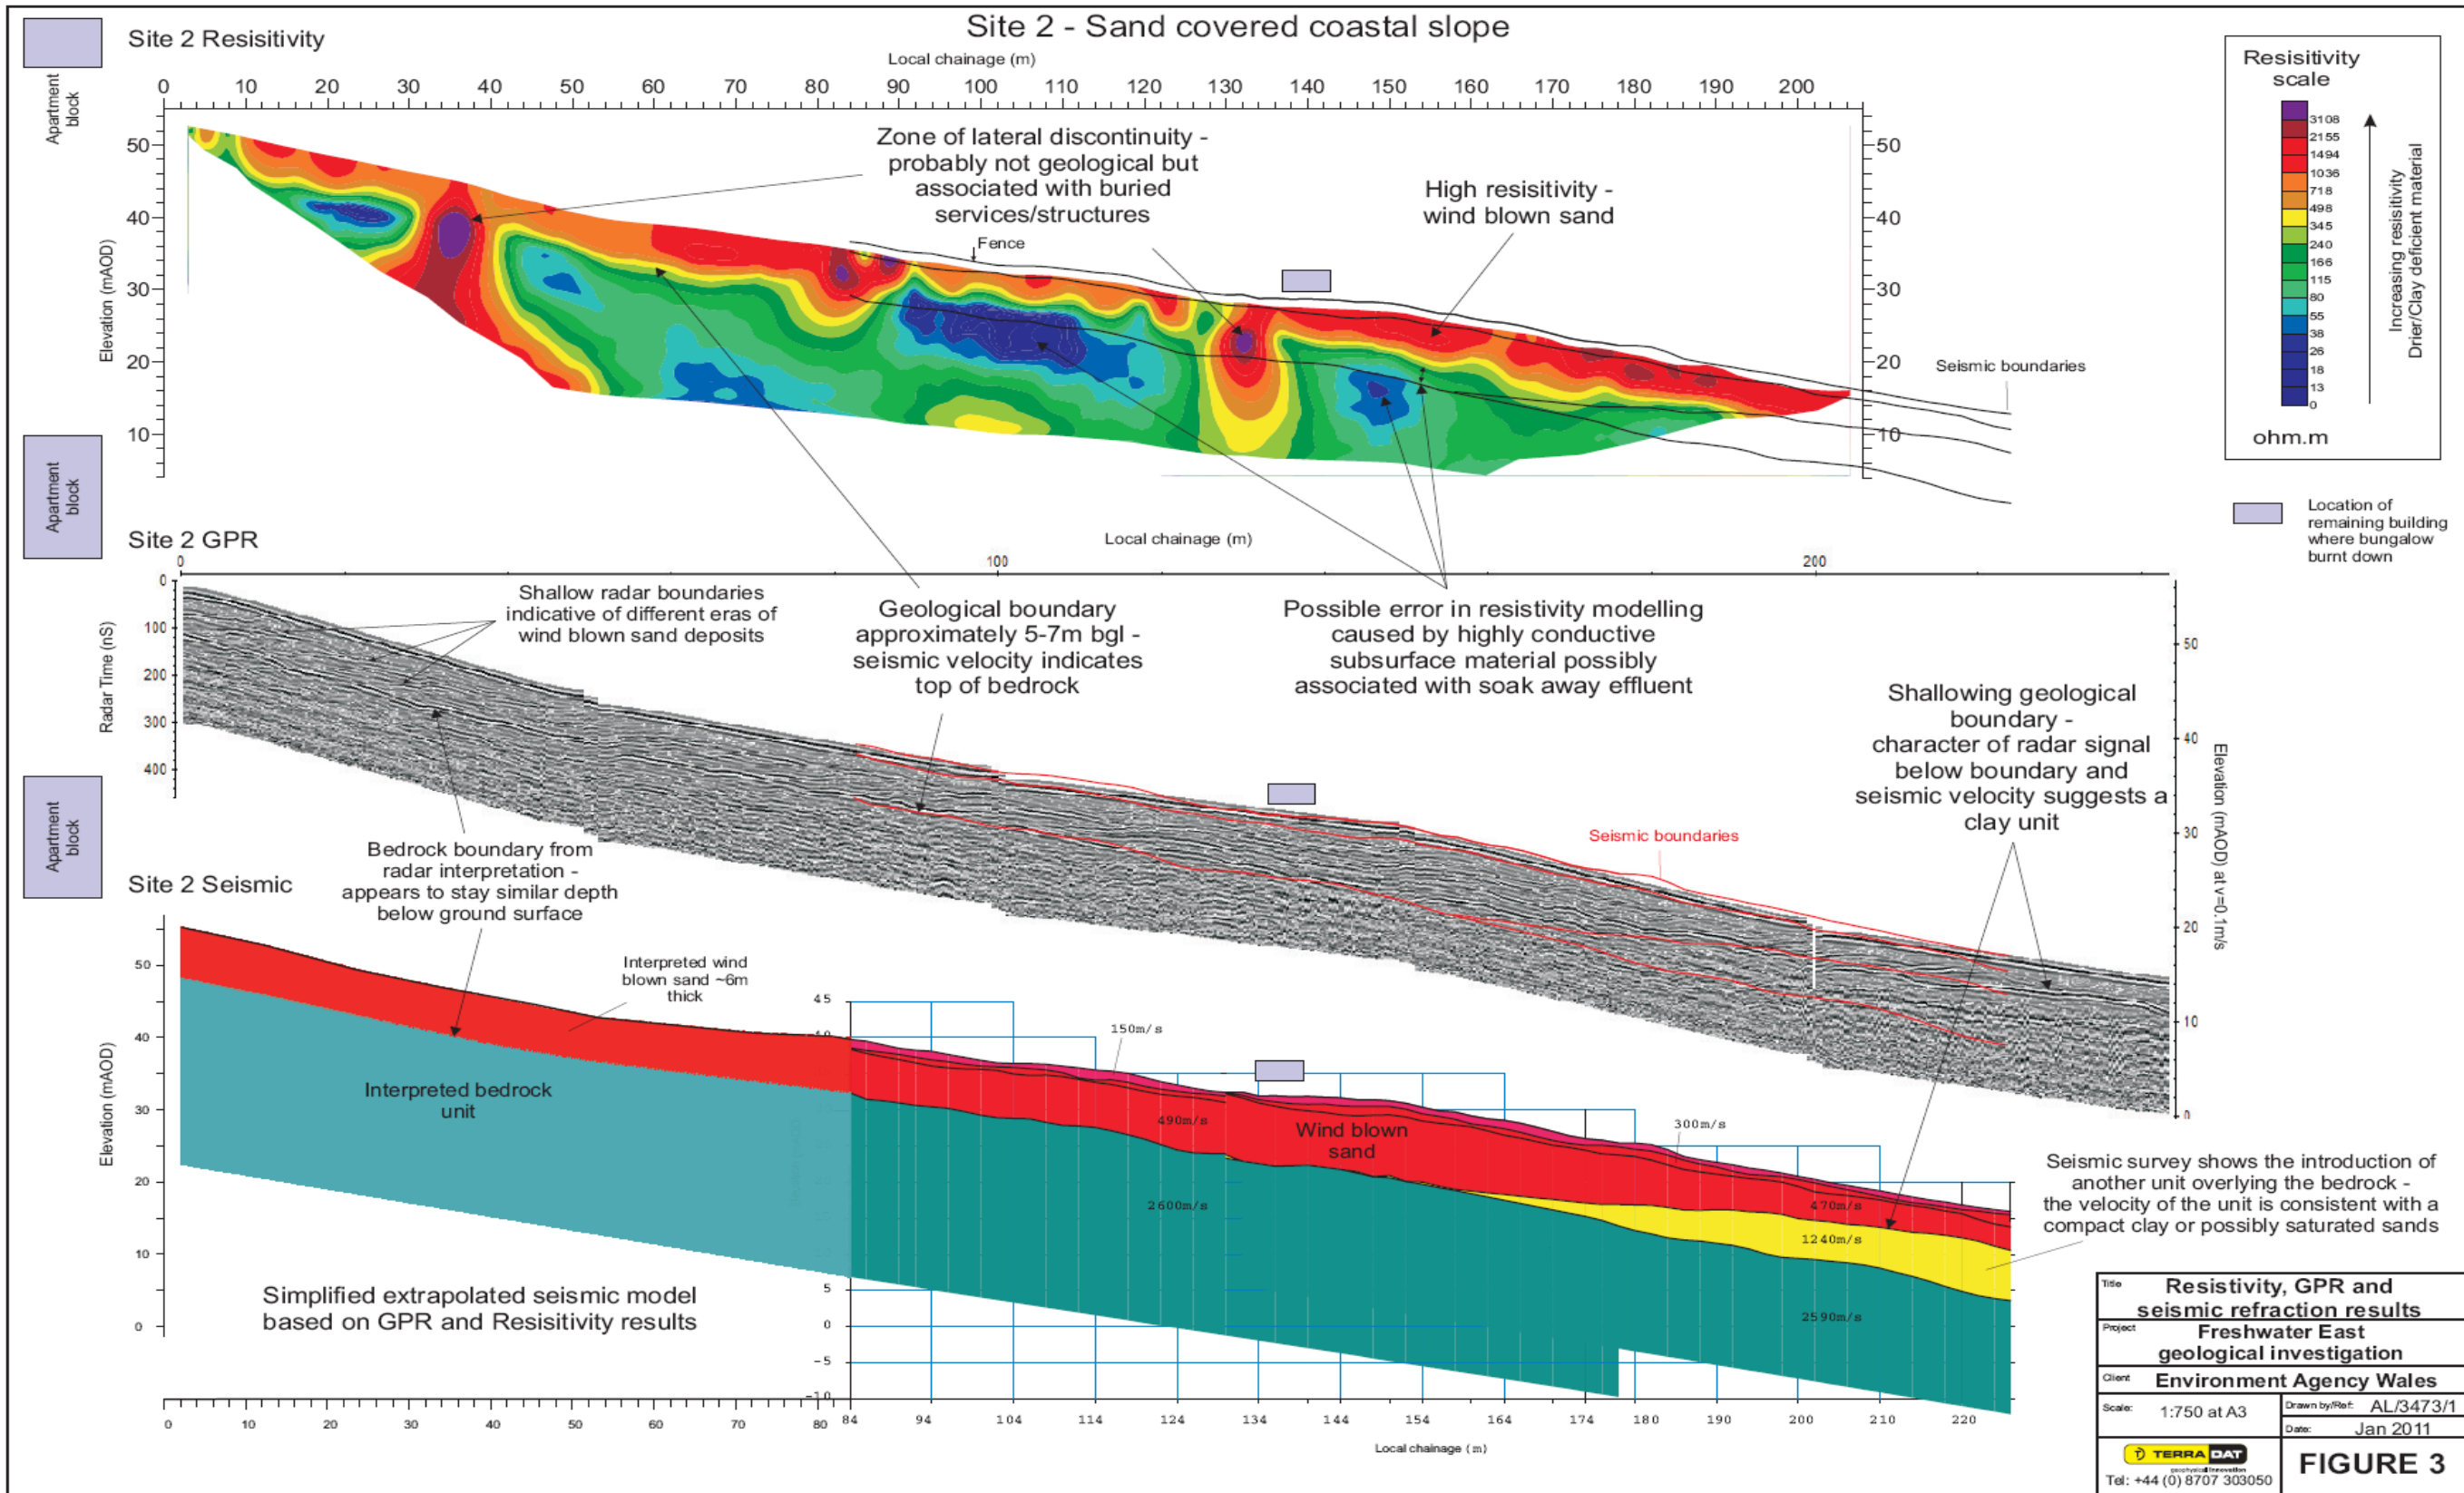
Figure 7 : Geophysical Cross Section 2. Devon Court Flats.

This comprised a 220m survey line (Figure 7) running north-south, starting at the public footpath by Devon Court Flats and extending down towards the coast. The location of this line was based upon the requirement for a straight line profile down through the dunes. It is also downgradient of perhaps the largest sewage treatment system in Freshwater East, that serving the Devon Court flats.

The section shows there is a relatively even depth of blown sand (some 5-7m) above the bedrock, in the area below Devon Court flats. In the approximate location where the property 'Wavecrest' used to stand, the seismic survey detected another layer. This is either a layer of soliflucted clay or saturated blown sand.
