Investigation into the impact of sewage effluent discharges on water quality in the Freshwater East area, Pembrokeshire

August 2012

Environment Agency Wales. 2012. Hydrogeological assessment of Freshwater East, Pembrokeshire. Internal Report.

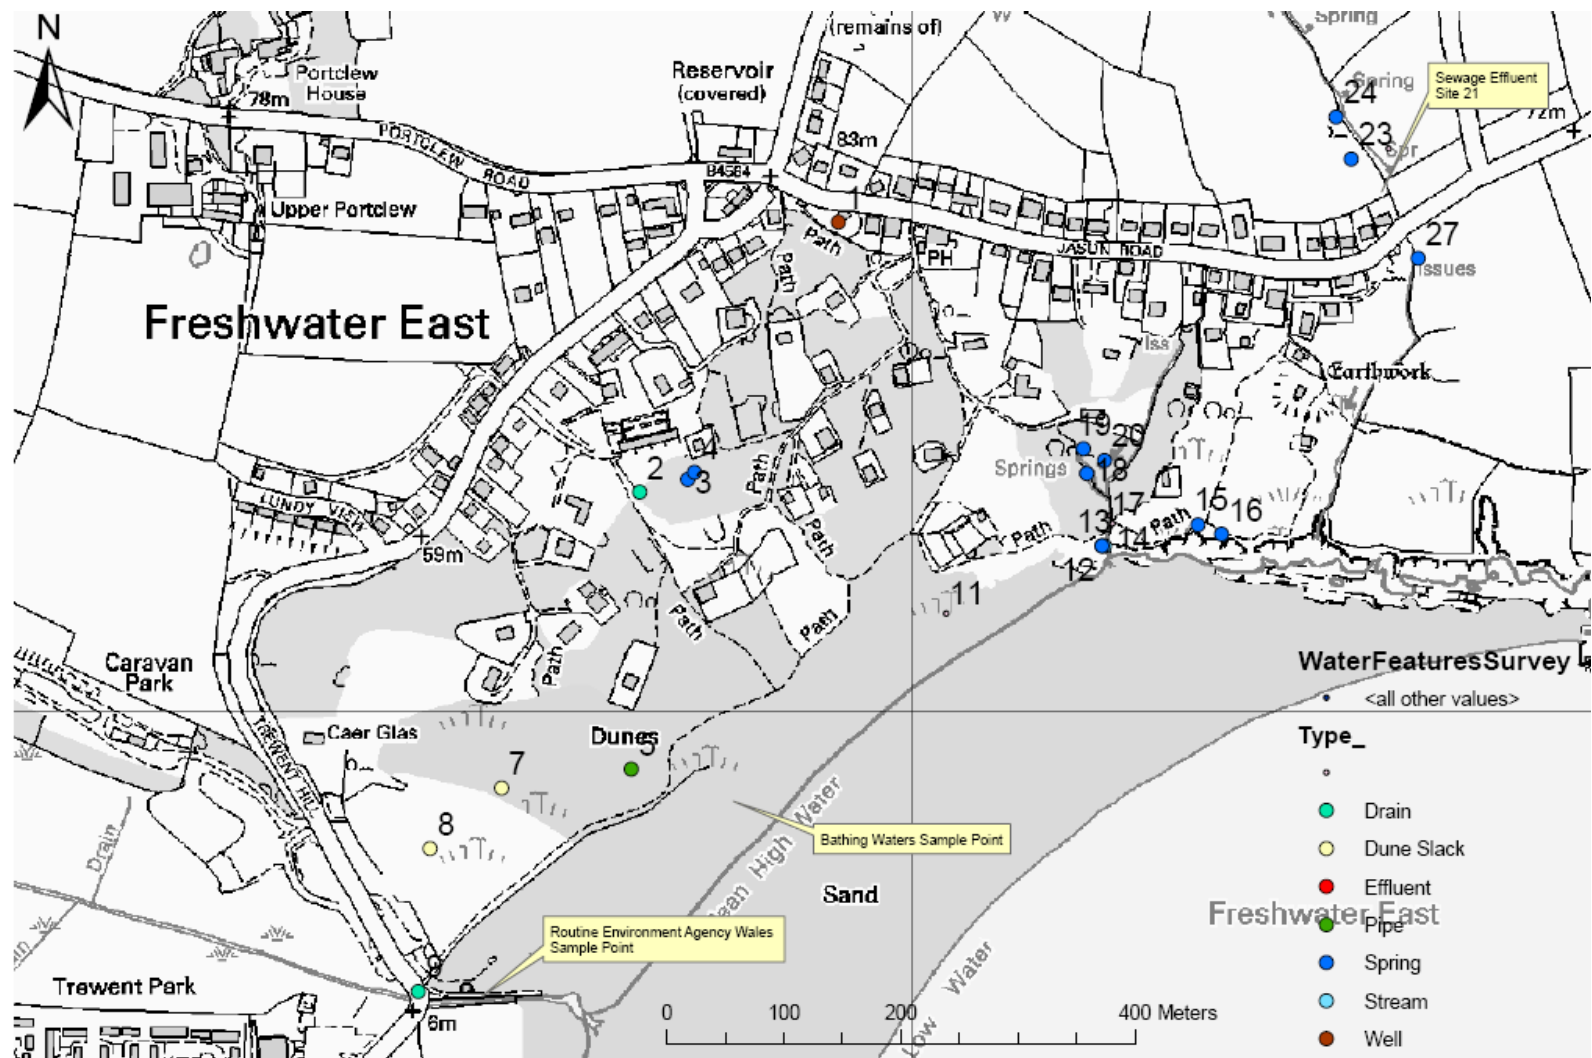
Figure 1. Water Features Survey Locations (OS Basemap)

The water features survey (WFS) was undertaken on the 16th of January 2012 by Gareth Farr and Rod Thomas of Environment Agency Wales (see Figure 1 and Appendix 1).

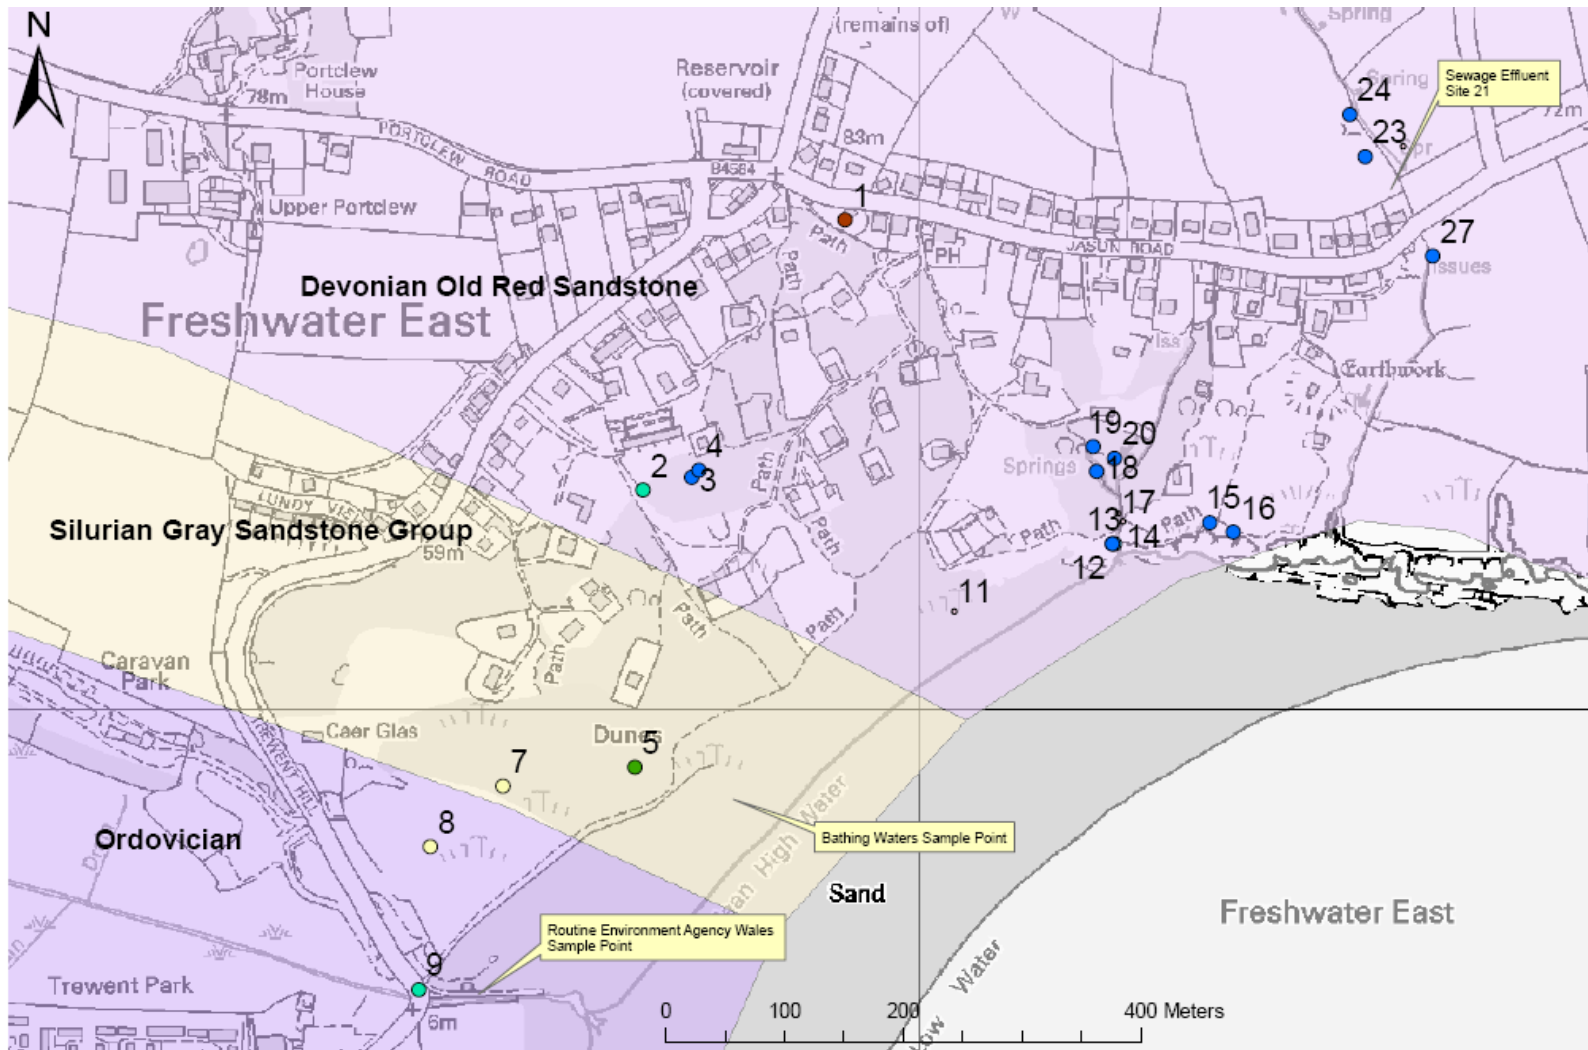
Figure 2. Bedrock geology (BGS 1:50,000)

The bedrock geology (Figure 2) comprises Silurian and Lower Devonian strata, which are classed as secondary aquifers. The geology is faulted and orogenic earth movements have resulted in the beds dipping at near vertical or subvertical angles, with a EEN-SSW strike. Where faults occur the displacement maybe up to 50m (Sid Howells pers comms) putting Silurian strata in contact with the Devonian Lower Old Red Sandstone.

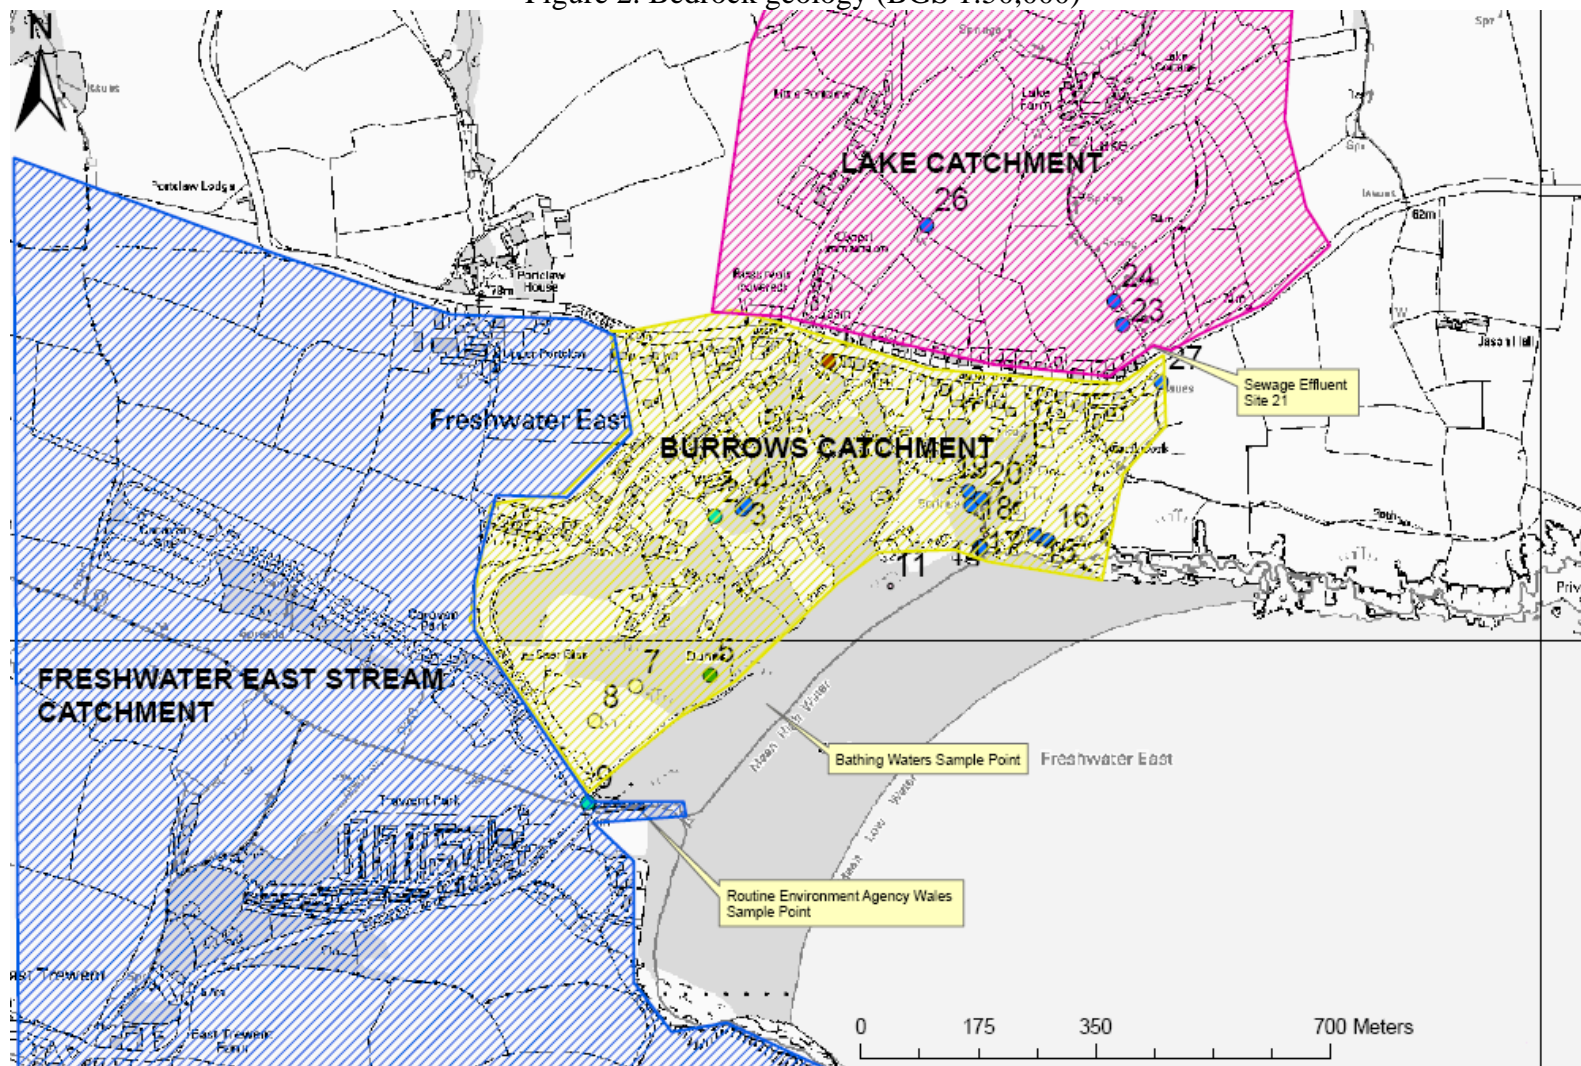
Figure 3: Proposed surface water catchments (OS Basemap)

There are three surface water catchments in the Freshwater East area (Figure 3) called Burrows, Lake and Freshwater East Stream. The catchments will dictate the direction of surface water, shallow soil water and groundwater flow. It is in the Burrows catchment that the majority of sewage effluent is discharged. Effluent will generally follow the same flow path as surface water within each catchment.

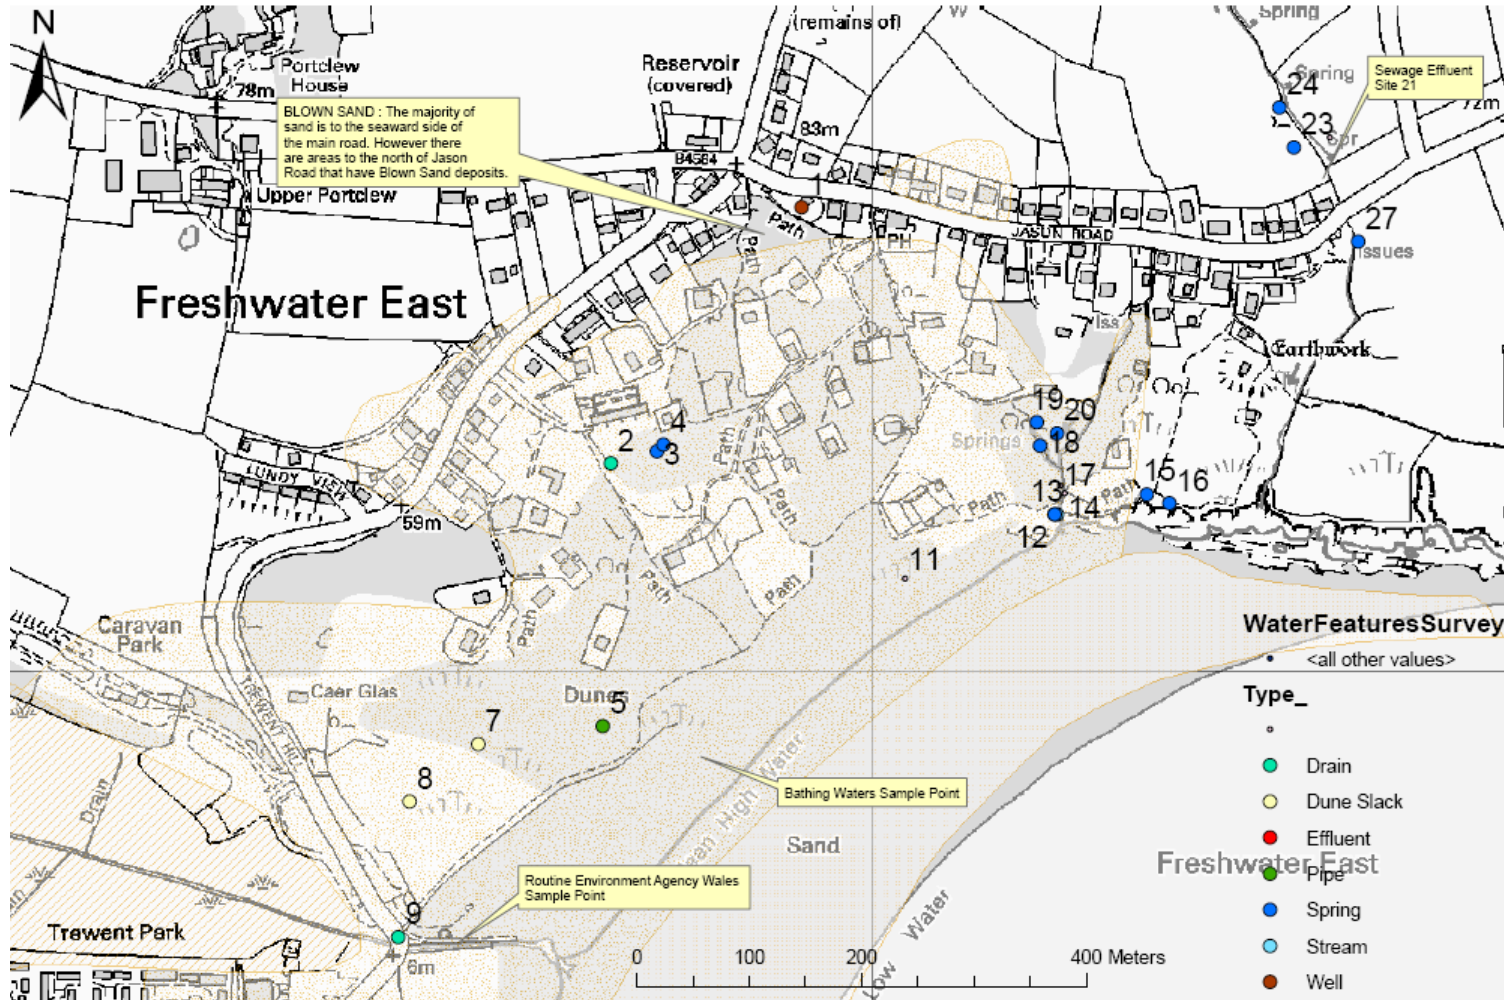
Figure 4. Superficial geology (Blown Sands) BGS 1:50K Superficial Map

The blown sand deposits (Figure 4 & 5) which overly the soliflucted deposits are wide ranging in their distribution and thickness. The blown sands are visible and form the dunes and burrows at Freshwater East. Onshore winds have led to sands being blown over the crest of the ridge (marked by Jason Road). Blown sand deposits are thicker at the western end of Jason Road and appear to be thinner or non existent at the eastern end.
